**IN THE PROVINCIAL COURT OF ALBERTA**  
**CRIMINAL DIVISION**

**PRAIRIE MINES & ROYALTY ULC (formerly known as  
Coal Valley Resources Inc.)**

**AGREED STATEMENT OF FACTS**

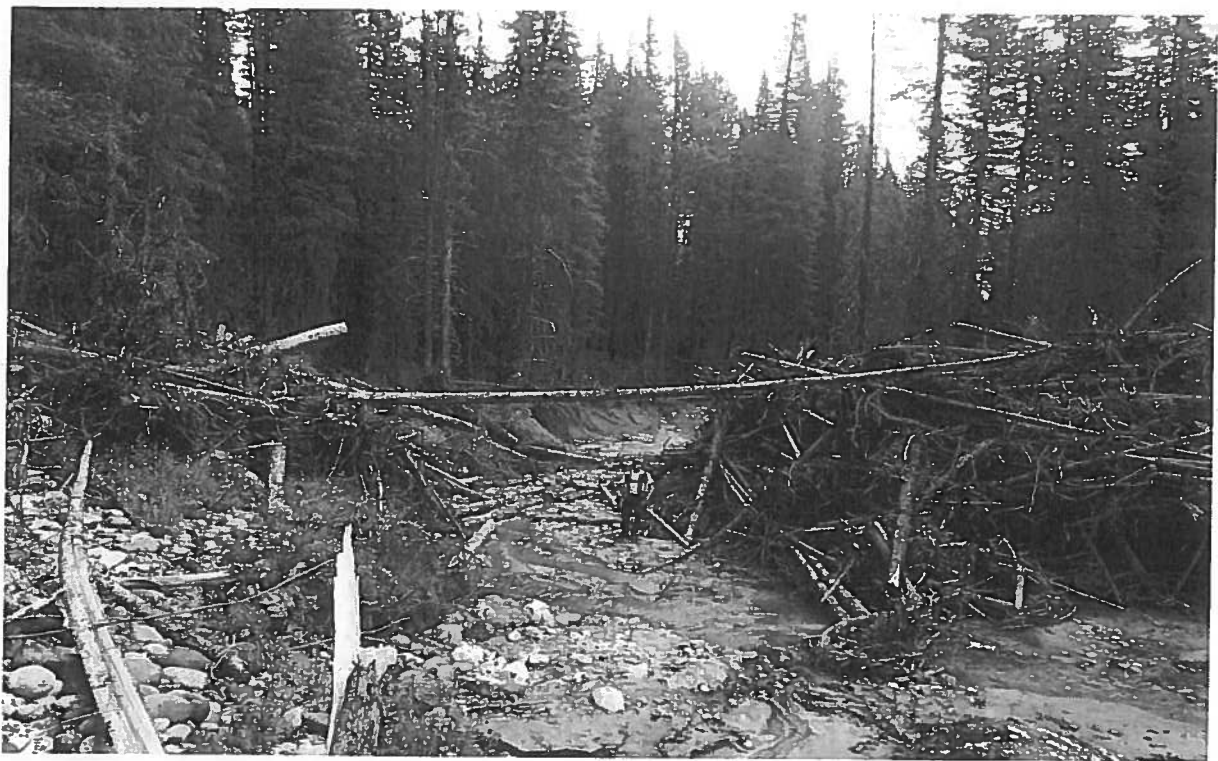
## Appendix A

40. As the release moved downhill, it created significant erosion and picked up additional natural material. For approximately 4-5 km of Apetowun Creek (known as upper Apetowun Creek), trees for many metres on both sides of the creek bed were pushed down, uprooted and carried downstream. Large log jams resulted. Creek banks were scoured, eroded and deeply undercut, leaving them unstable. The release removed soil, rock, vegetation and aquatic life, including fish, from the Creek and adjacent riparian area. Debris and sediment were deposited along the creek bed and riparian area.  
[See attached photo at Appendix A taken of upper Apetowun Creek in June 2015.]

Photo of upper Apetowun Creek taken in June 2015 showing erosion and debris and sediment deposited from release along the creek bed and riparian area.

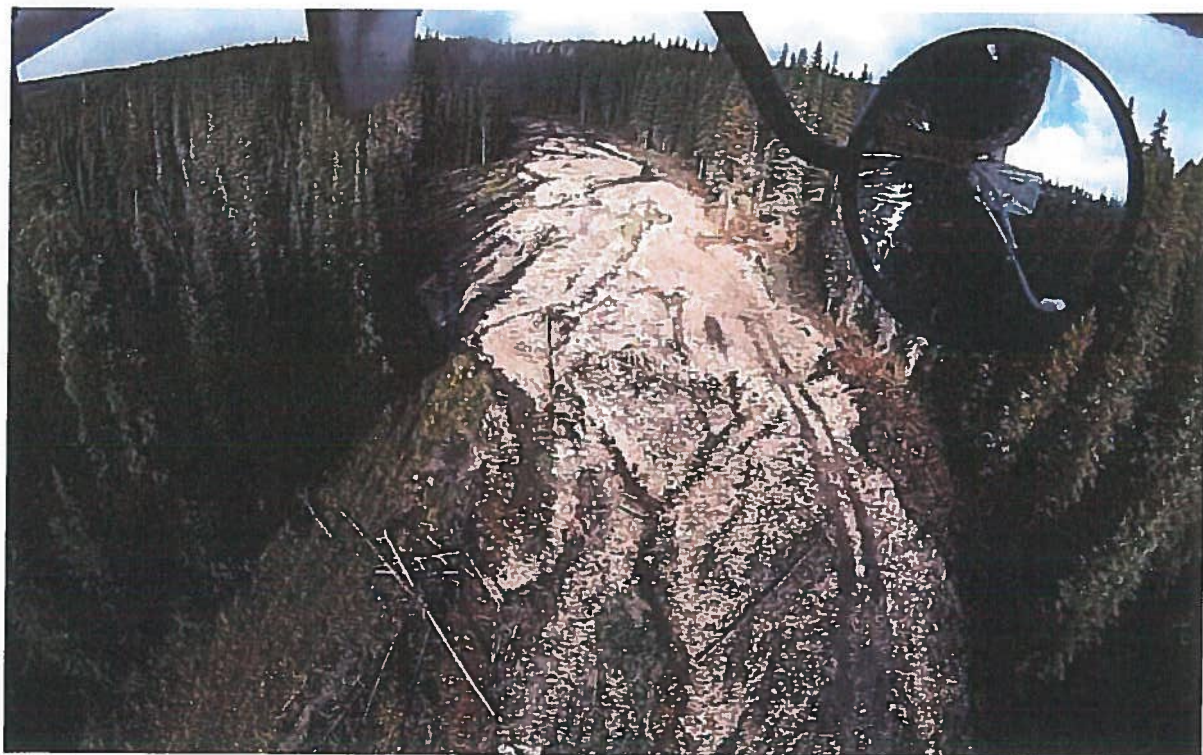
## Appendix B

41. Within upper Apetowun Creek, at a sharp bend and less steep slope, the wastewater spread and ran overland and into the adjacent forest. A large amount of water and sediment was deposited in the forested area. This resulted in the removal of some energy from the flow. The swath of the release here was approximately 60m wide. It created the appearance of a delta where there was once a narrow, deep creek channel.  
[See attached photo at Appendix B taken of upper Apetowun Creek in September 2014.]

Photo taken in September 2014 of upper Apetowun Creek showing significant sediment deposition and braiding of the creek, where pre-incident there was a distinct creek channel.

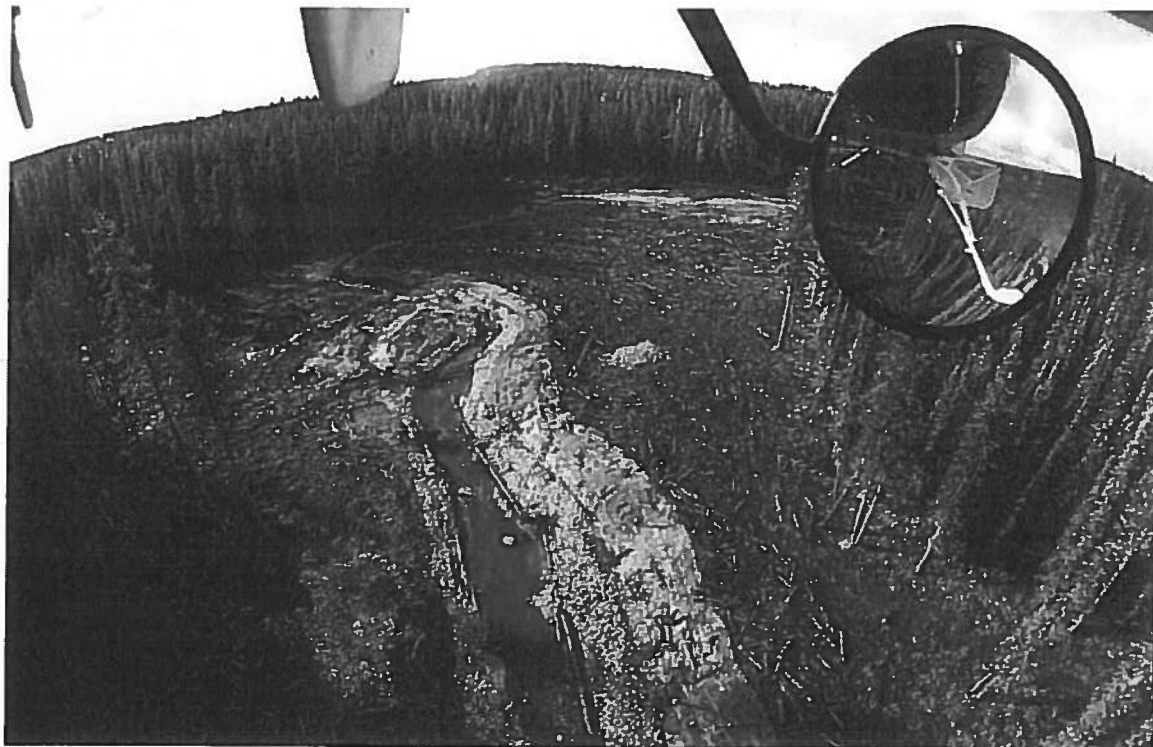
## Appendix C

42. Further downstream of this point, at the Dx Road, there was a culvert through which the creek normally flowed. Wastewater backed up at the culvert and created a debris dam of conifers/plants before the water washed out the Road. The backed-up water created a pool which protected some of the natural creek formation a few hundred metres upstream of the Dx Road, though up to 3 feet of sediment was deposited in the creek bed. Because the wastewater backed up and then blew out the culvert and Dx Road, the wastewater had energy again as it flowed down the Creek past the Road – scouring away banks and trees/plants, creating braiding, and depositing significant amounts of sediment for approximately 1200m downstream.  
[See attached photo at Appendix C taken of upper Apetowun Creek downstream of the Dx Road at approximately kilometre 3.5 in September 2014.]

Photo taken in September 2014 of upper Apetowun Creek downstream of the Dx Road at approximately kilometre 3.5, showing the swath of trees and vegetation removed by the release.
