# **Investigation Summary Report**

## **2015-004: Murphy Oil Company Ltd.**

**Licence No. P44181-016**

**March 3, 2017**

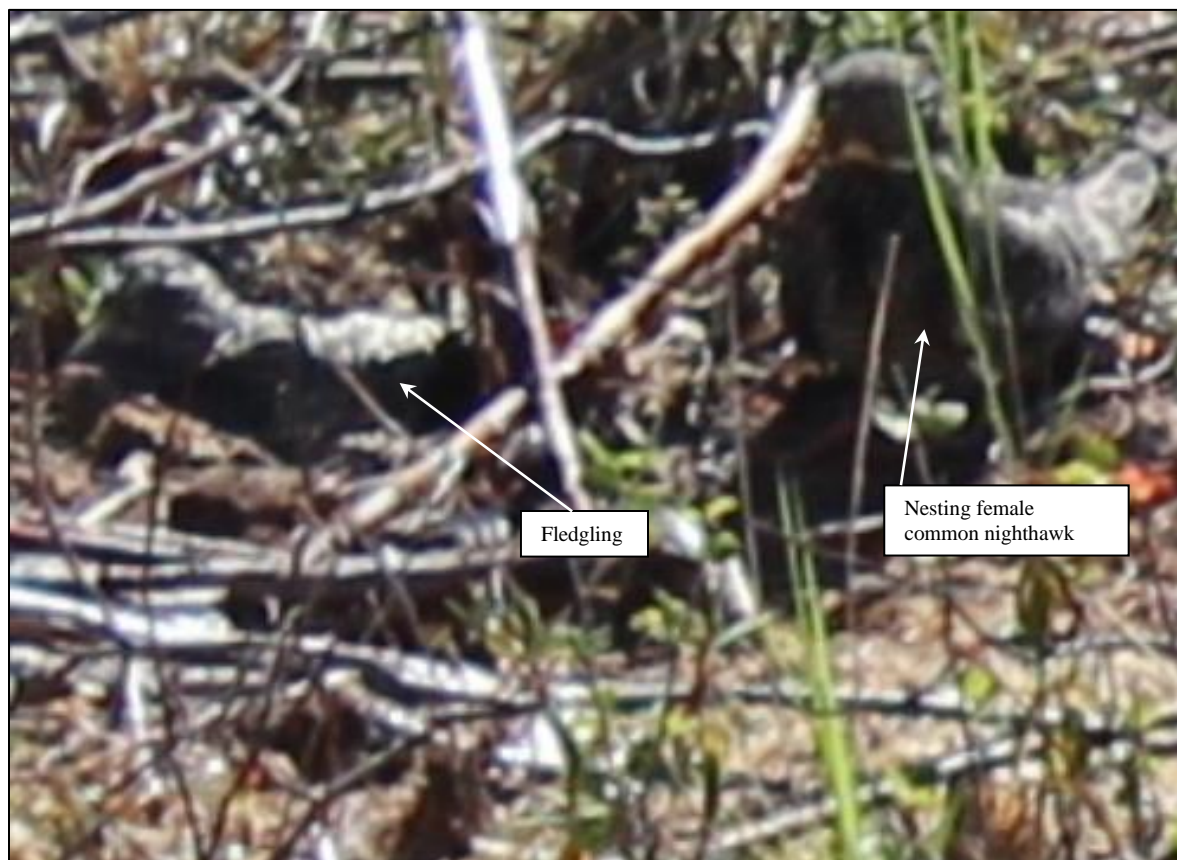
**Figure 4. A common nighthawk nest. A close-up of one of two nests found within Area 1.**

When AER investigation staff visited the site on July 30, 2015, it was noted that two pairs of nesting common nighthawks had moved into Area 1. Murphy's crews marked the nesting sites and appointed staff to monitor access around the two nesting areas. AER investigators noted at least one fledgling in one of the nests.
